# SeaShield System Selected for Repairs to Indonesian Chemical Jetty

Project Summary	
Product type: Sub Sea / Splash Zone Coating	
<b>Country:</b>	Indonesia
<b>Location:</b>	Cilegon, Banten
<b>Object:</b>	Jetty Piles
<b>Problem:</b>	Corrosion prevention
<b>Product solution:</b>	Denso SeaShield

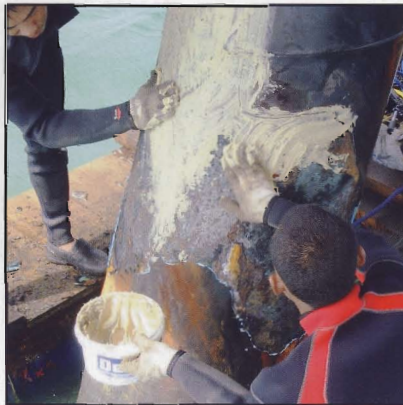
2. Denso S105 paste is then applied to the cleaned area only.

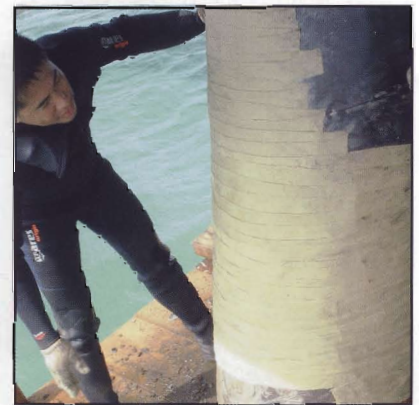
3. Strips of Densyl Tape are then placed over the Denso S105 Paste to bring the repair area up to the surrounding level.

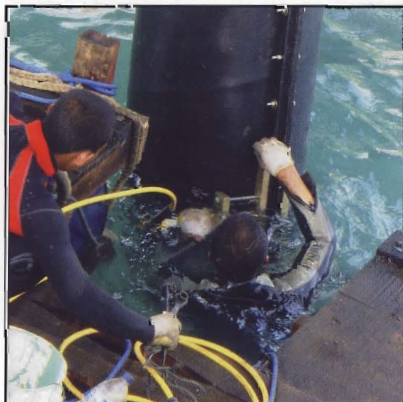
5. Finally SeaShield 2000 FD Jackets are attached using a hydraulic pump to compress the joint to enable easy bolting.
